SYNGENE INTERNATIONAL LTD, VELANKANI TECH PARK, ACCESSIBILITY AUDIT REPORT

PREPARED BY SVADHIN SOLUTIONS

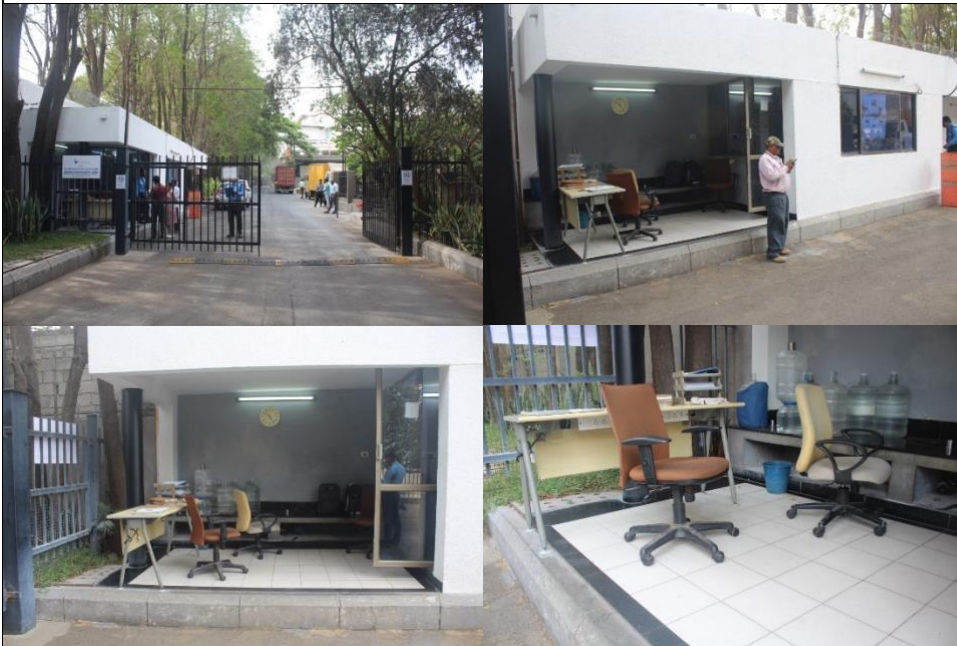
- There is no pedestrian pathway demarcated and kept at Gate 5 which would put PwD pedestrians walking into the campus at safety risk as they would be using the vehicular route

- The speed breaker in front of the Gate 5 in the pedestrian walkway makes this route harder to navigate for certain PwDs making this entry gate non-compliant

- The height of the security sign-in counter at Gate 5 is inaccessible for wheelchair users and certain other PwDs
- There is no dedicated walkway leading from Gate 5 to the building entrance making this route non-compliant and unsafe for PwD movement

- Gate 6 pedestrian exit path has no dedicated walkway and has uneven surface making it non-compliant and unsafe for certain PwDs
- The turning space after the Gate 6 pedestrian exit gate is non-compliant and will be hard for certain wheelchair users to use

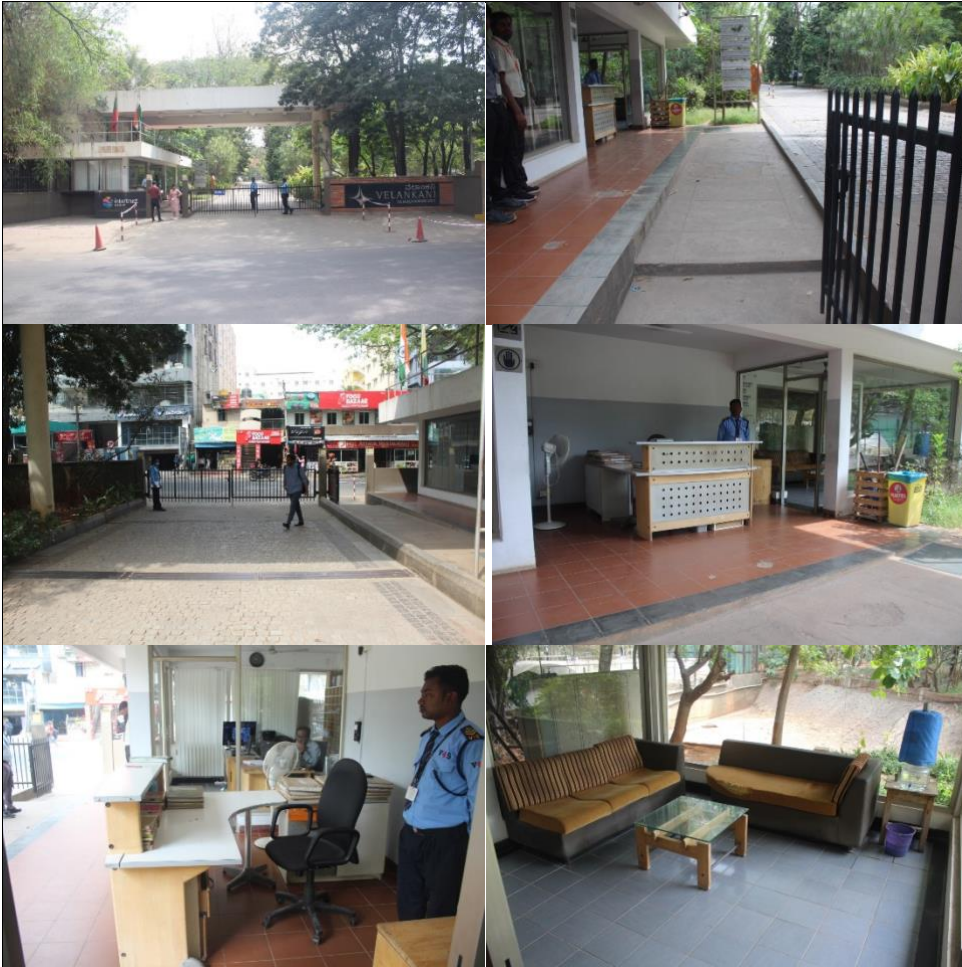
<ul style="list-style-type: none"> ➤ All the three campus entry/exit gates lack clear directional signage leading to the Syngene building making navigation non-compliant and inaccessible to PwDs

- There is no continuously running footpath leading from Gate 2 to the building entrance and the walkways have uneven surface making this route non-compliant and unsafe for PwD movement
- There are no tactile pictographic maps placed at the different gates as required by compliance to support people with visual impairment to navigate around the campus to reach their destinations
- There are no assistance protocols in place to support PwDs including how to interact with people with different disabilities as well as training in sign language to support people with hearing impairment
- Gratings around the campus pedestrian routes have non-compliant opening widths and can be safe for PwDs using mobility aids

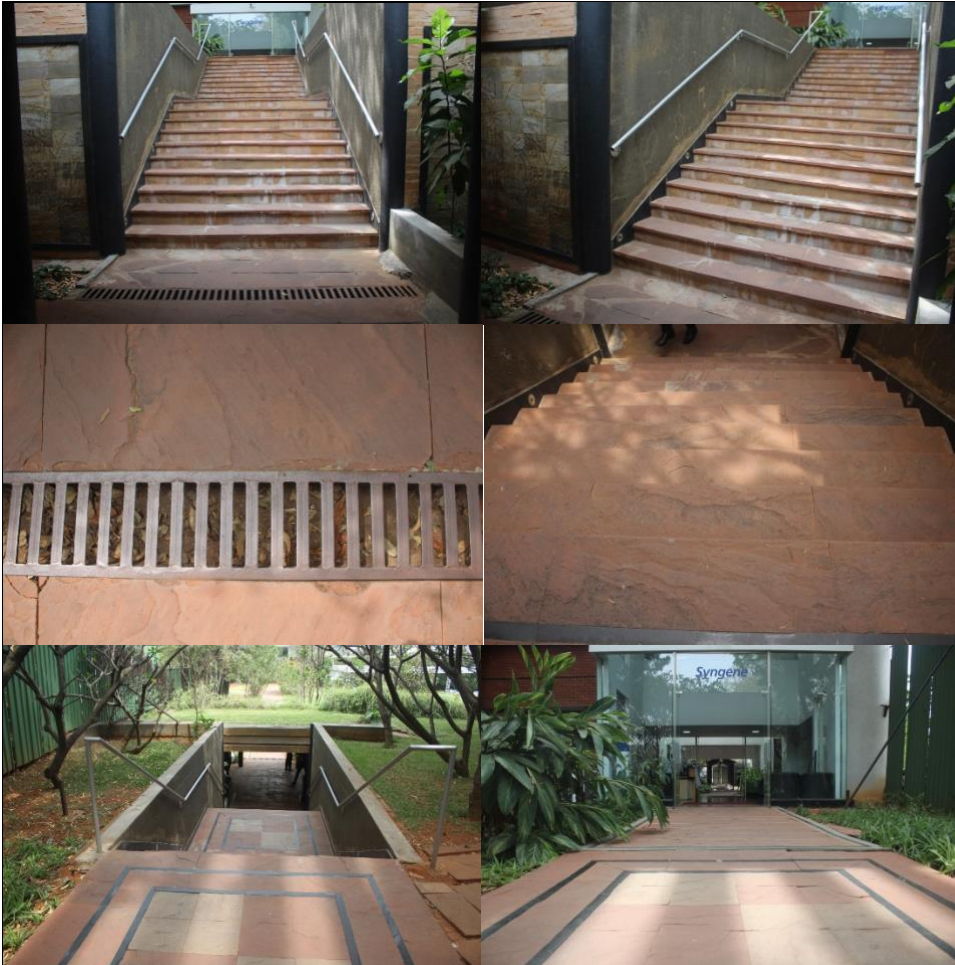
| | <ul style="list-style-type: none"> ➤ Entry route to the main building from Gate 2 has flights of steps leading to it without an accessible egress route making this route and entry door inaccessible for wheelchair users ➤ Entry route to the main building from Gate 2 have gratings along the path with non-compliant openings making this non-compliant and unsafe for people using mobility aids |

- Flights of steps to the building main entrance connecting from Gate 2 have handrails placed at non-compliant heights without extensions, no colour markings on each of the step treads and no signage making this entry route steps non-compliant and unsafe for PwDs other than wheelchair users

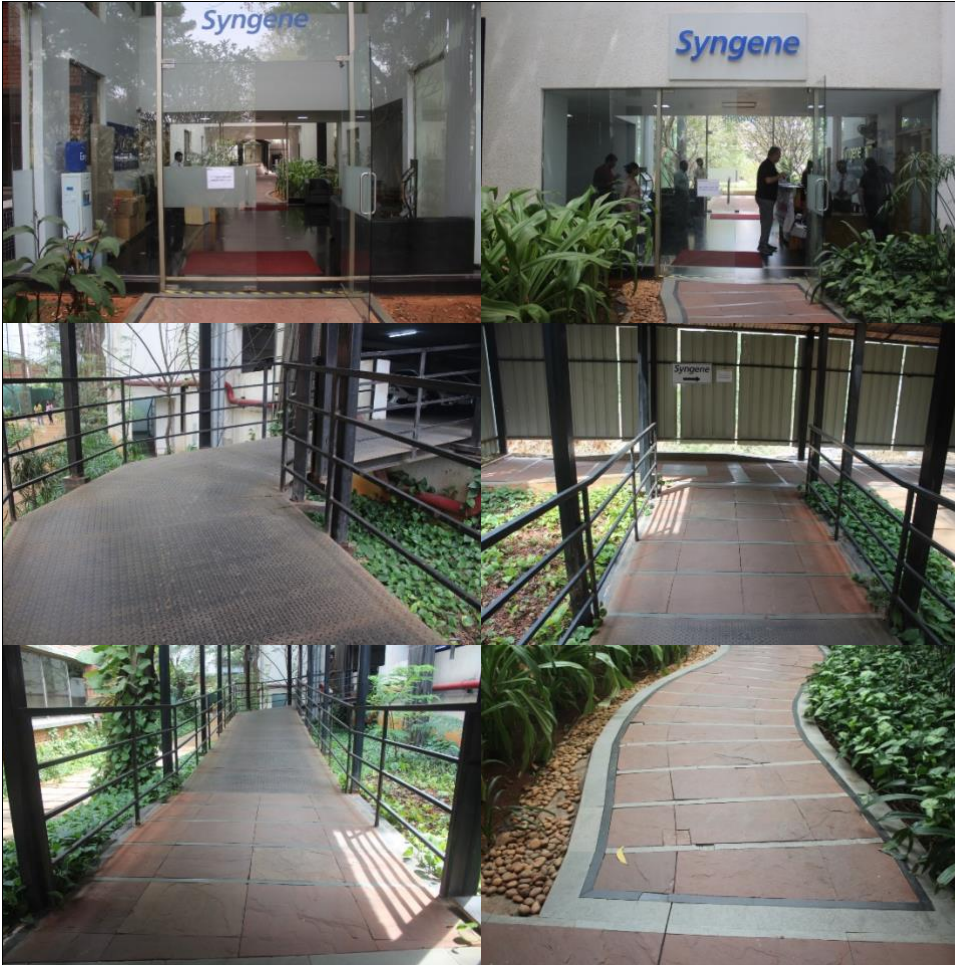
- Entry route to the main building from Gate 5 via the parking lot has an inaccessible ramp with inaccessible gradient, missing mid-landings, no continuously running dual level handrails on both sides with extensions, no edge protection, handrails placed at non-compliant heights, and the shape of the handrail is of inaccessible type making this ramp inaccessible and non-compliant for PwDs

- The path leading from the ramp to the building main entrance has uneven surface at certain parts making this route unsafe for PwDs
- Both the building entry/exit doors have high door tension, handles placed at inaccessible heights, no dual level colour bands on the glass panels and the doors, door frames that are not distinguishable from the surrounding glass wall panels and no provisions for accessible signage placed at accessible heights with braille and tactile making these entries/exits non-compliant and inaccessible for PwDs

- The loose mats at both the main entrance doors can be unsafe for PwDs and are non-compliant

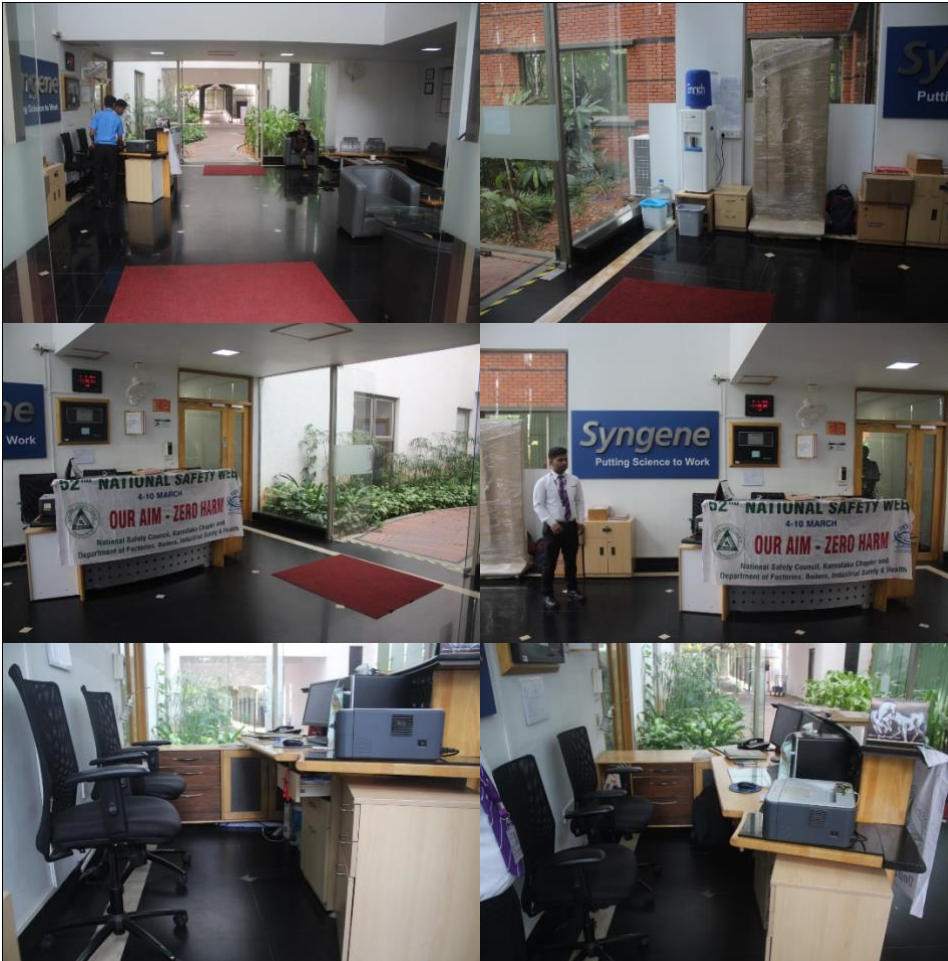
- The reception has an inaccessible counter which does not have dual level counters with an accessible lower level counter having knee clearance for wheelchair users and people with dwarfism and lacks an accessible identification signage making this counter non-compliant and inaccessible for PwDs

- The storage cabinets under the reception table have non-compliant type of handles and lack braille and tactile labels making them non-compliant and inaccessible for certain PwDs

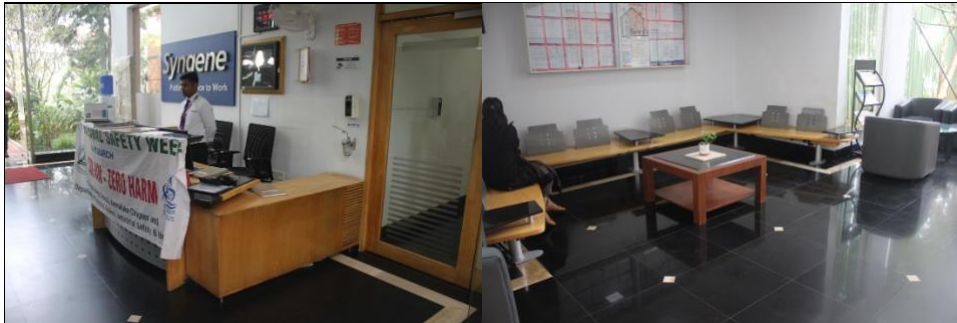
- The access card readers and the PTRs at the floor entry door are placed at non-compliant to inaccessible heights and they do not have provisions for braille and tactile identification labels making them non-compliant and inaccessible for people with visual impairment

- The loose mats placed in the reception area can be unsafe for PwDs and are non-compliant
- Parts of the reception area flooring have high reflective index which can be disorienting for certain PwDs and is unsafe and non-compliant
- The instructional signage placed in the reception area is partially at non-compliant to inaccessible heights with no provisions for braille and tactile and/or audio out provisions making these signage inaccessible for people with visual impairment

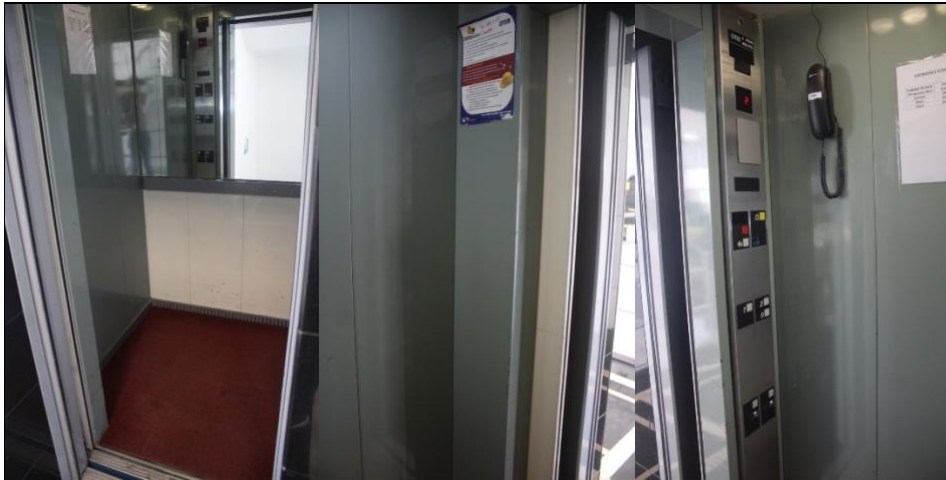
- The emergency phone inside the lift is placed at an inaccessible height and does not have an accessible identification signage making it non-compliant and inaccessible for PwDs
- The lift has no audio out to assist people with visual impairment making it inaccessible for them

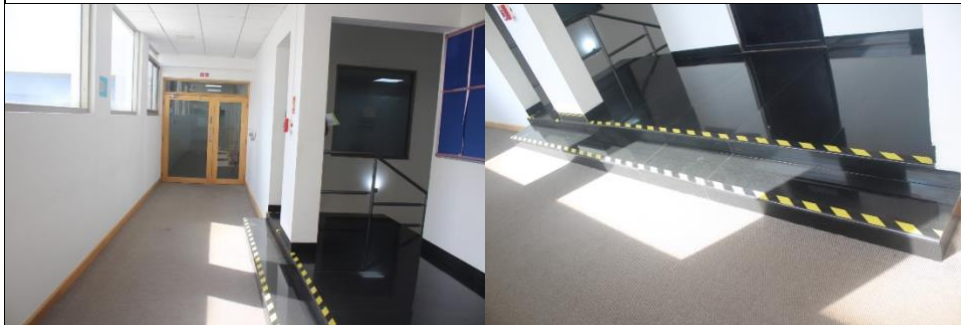
- Both the main staircases (front and back) have no floor identification signage on the staircase floor landings with provisions for braille and tactile making navigation challenging, non-compliant and inaccessible for PwDs
- Both the main staircases (front and back) have emergency instructional/directional signage placed at non-compliant and inaccessible heights without provisions for braille and tactile making them non-compliant and inaccessible for people with visual impairment and certain other PwDs
- The central running handrails of both the staircases (front and back) do not have handrail extensions at the top and bottom landings and the staircases are missing continuously running wall side handrails with extensions into the landings making both these staircases non-compliant and hard to use for certain PwDs

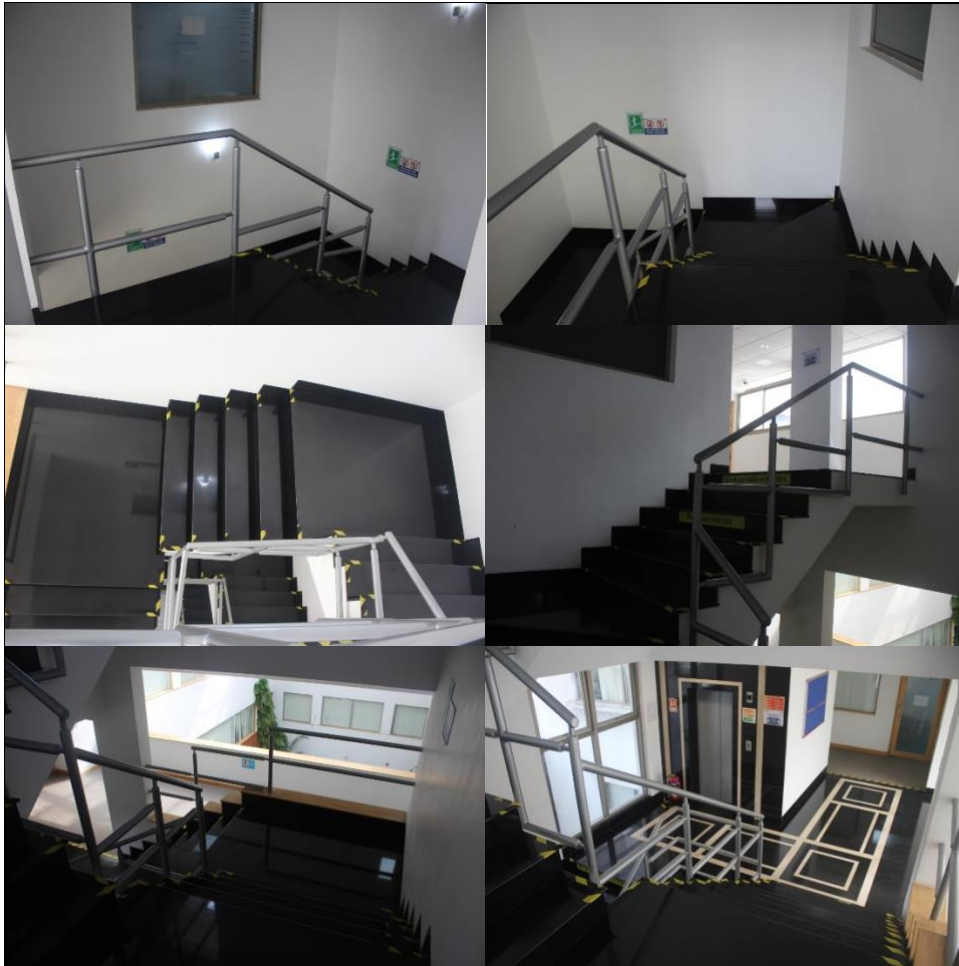
- The handrails are not completely accessible for people with visual impairment as they are lacking in braille markings for identification of the floor on each landing

- The front staircase handrails on the left side below the beam for the flight that is coming into the landing areas have inaccessible clearance from handrail to the beam making this part of the handrails possibly unsafe for certain PwDs and the head clearance non-compliant

- All the steps in both the staircases have non-compliant colour markings and there are no antiskid provisions for all the step treads making both the staircases non-compliant and unsafe for PwDs

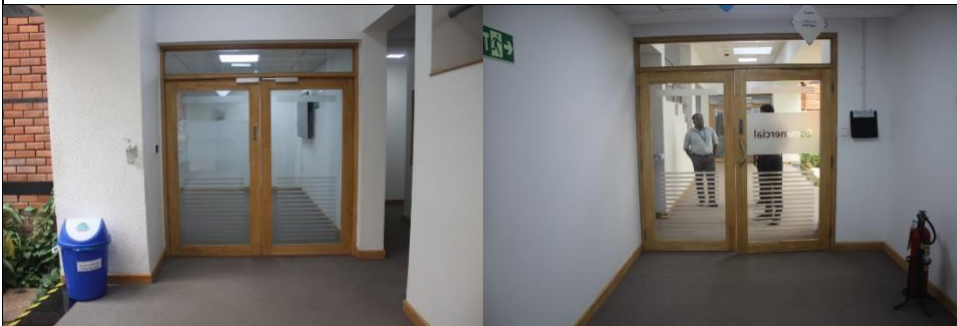
- None of the floor entrance doors have an accessible identification signage with provisions for braille and tactile with strong colour contrast making them inaccessible and non-compliant
- All the floor entry doors have high door tension except for the floor entry door on third floor near the pantry and handles placed at inaccessible heights making them non-compliant and inaccessible for PwDs
- Both the third floor entry doors towards the toilet blocks have inaccessible pull side door clearances making them non-compliant and inaccessible for PwDs

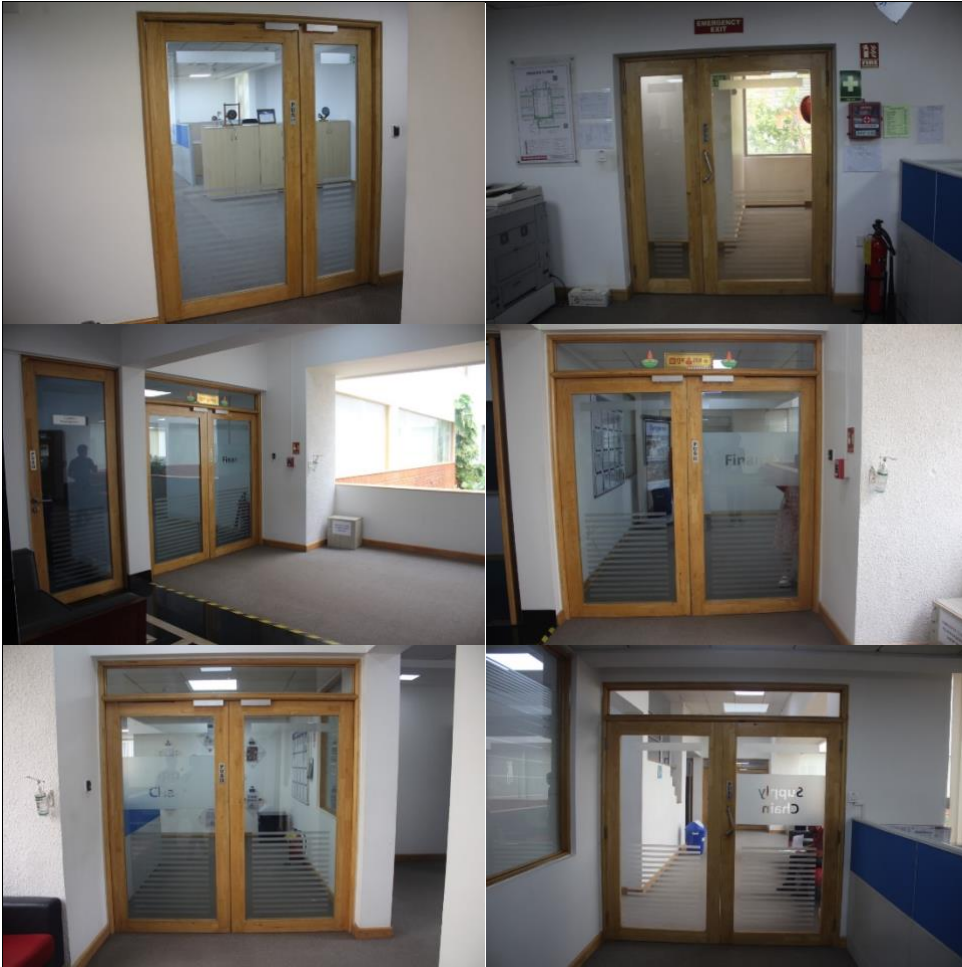
- The access card readers and the PTRs placed next to all the floor entry doors are at non-compliant heights without any braille and tactile identification labels for people with visual impairment making them non-compliant

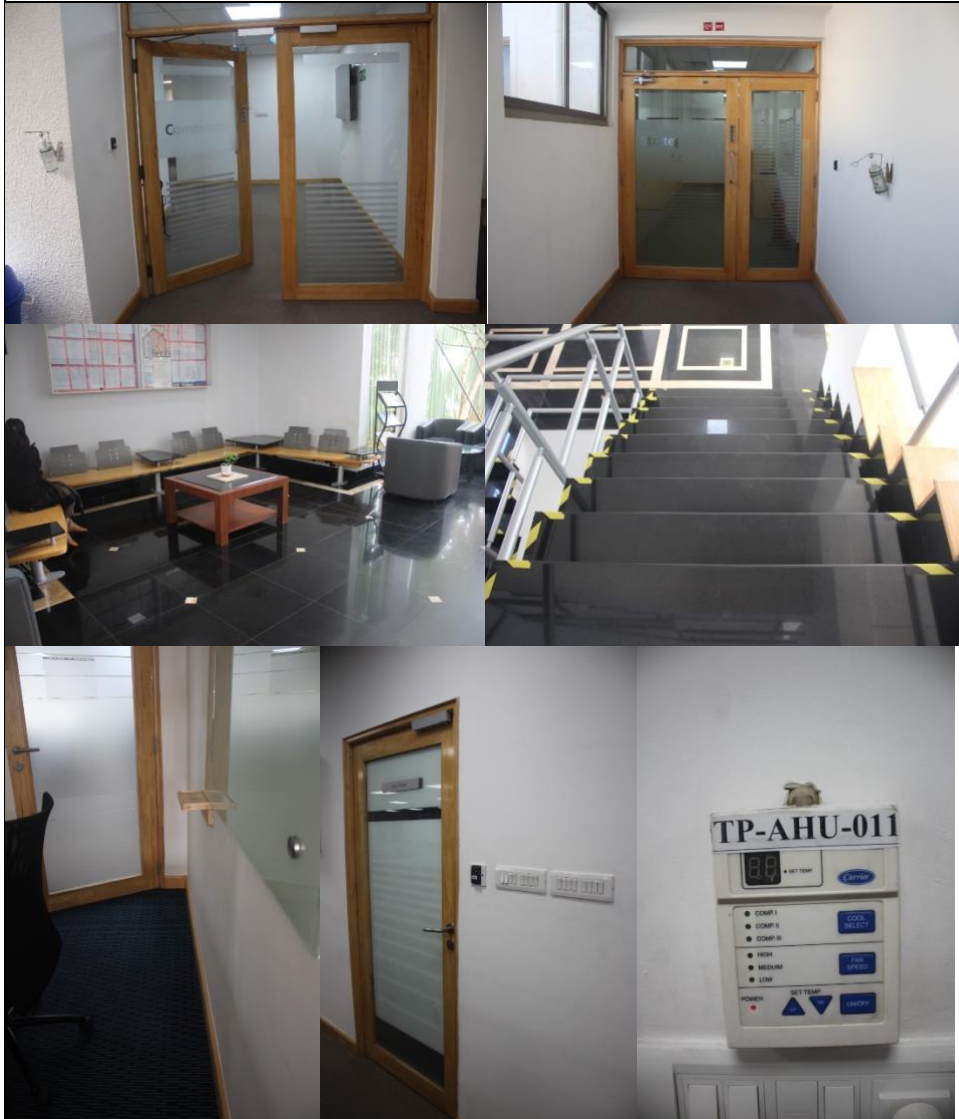
- None of the high usage doors like floor entry doors and the restroom doors have kick plates as required by compliance
- At certain areas like the reception, main staircase and the some parts of the lift lobby the flooring has high reflective index which gives out high glare and can be disorienting for PwDs making the flooring non-compliant and possibly unsafe for certain PwDs

- The wall mounted hand sanitizers are placed at inaccessible heights and act as projections making them inaccessible and unsafe for PwDs
- The access card readers and the PTRs placed next to all the floor entry doors are at non-compliant heights without any braille and tactile identification labels for people with visual impairment making them non-compliant

7	Doors: All high usage doors as specified, should have kick plates of 300 – 400 mm height placed on both sides to protect from wheelchairs and doors should have high contrast against the background wall	H	L
8	Glass Walls & Doors: For glass walls and doors, colour bands of minimum 75 mm thickness should be added at two levels of 800 mm and 1500 mm	H	L
9	Mats: For areas where mats are essential, create recessed areas for mats to ensure sunken mats they are at floor level and don't cause tripping	H	M
10	Mats: Where mats are unnecessary remove	H	-
11	Ramps: The ramps should be made accessible by correcting the gradient to 1:12 or 1:15 and the width should be made 1500 or 1800 mm between the handrails with landing of 1500 x 1500 mm on both ends with an edge protection up till 50 mm from the floor level on the sides of the ramp and mid-landings added as required by compliance	H	M
12	Step Treads: All step treads whether at entrances or in the staircases as marked in the barriers section, should have colour contrasting marking tape at the edge of the tread which is also anti-slip as shared in Guideline 6	H	M

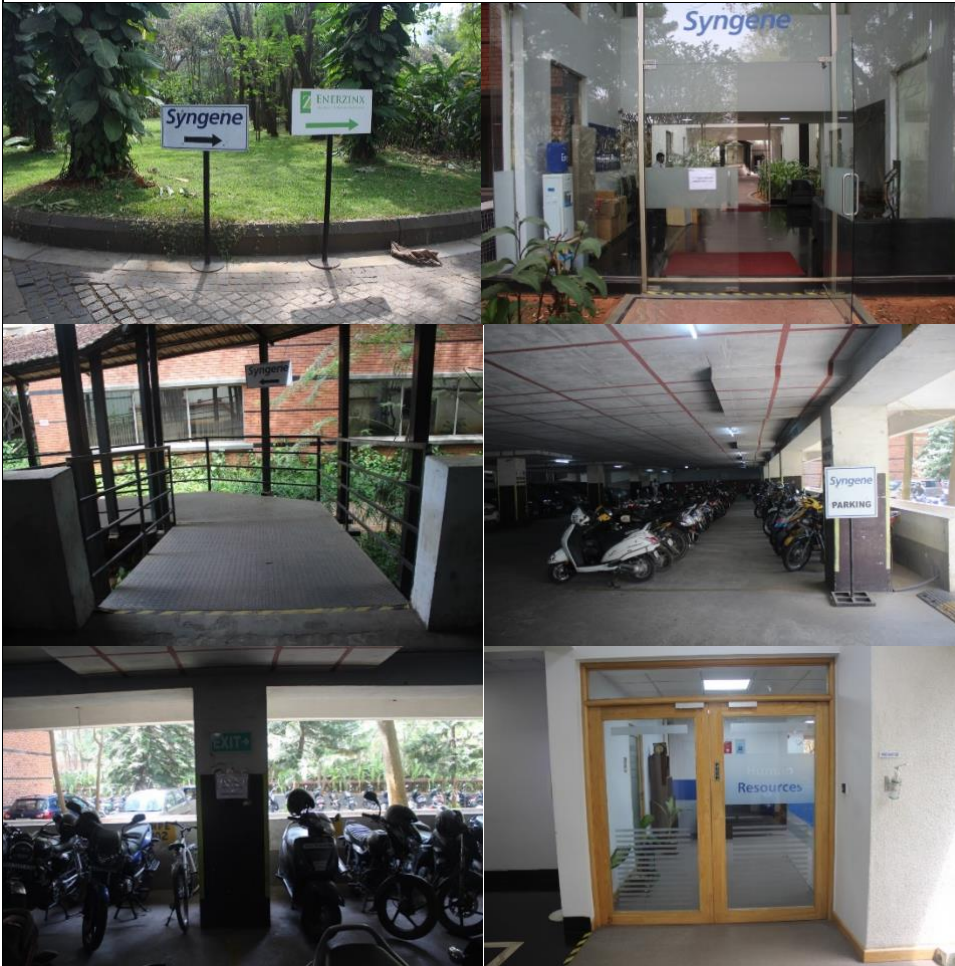
- All existing signage (identification, directional and emergency evacuation signage) throughout the office floors do not have provisions for braille and tactile to support PwDs towards general navigation as well as during an emergency evacuation and are placed at non-compliant to inaccessible heights

- A lot of rooms and areas are missing identification signage completely which makes them hard to identify and navigate to
- None of the floor entrances have accessible signage to support navigation between areas

- The accessible restroom signage have no clear content only a pictograph with no provisions for braille and tactile making them non-compliant and hard to read for certain PwDs

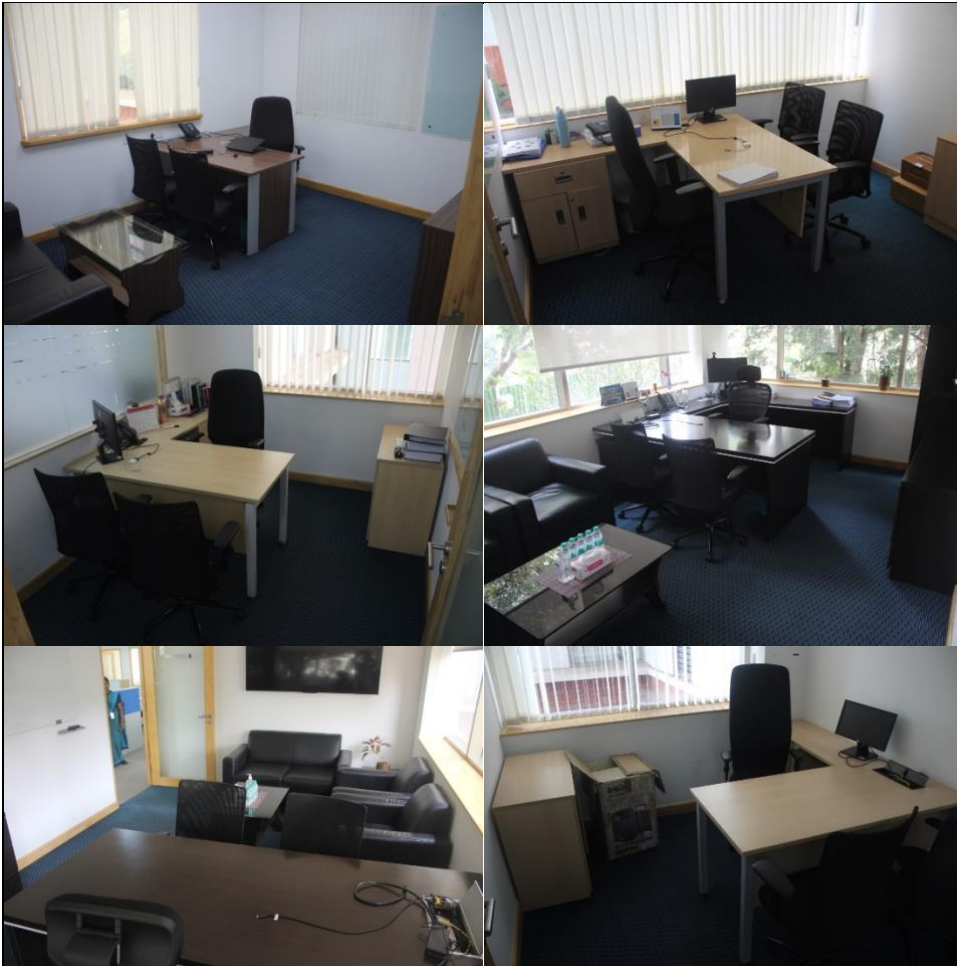
- All the full cabin entry doors have handles placed at non-compliant heights making these entries non-compliant
- Some of the full cabin entry doors have high door tension, some have non-compliant door widths and some have signage placed at non-compliant to inaccessible heights with no provisions for braille and tactile whereas the rest of the full cabins do not have an accessible signage at all making all the full cabin entries non-compliant and largely inaccessible for PwDs
- The ground floor VP cabin and one of the second floor corner full cabin don't have push side door clearances making these entries inaccessible for certain PwDs

- One of the half cabins on second floor as marked in the floor plan has non-compliant entry width
- Most of the personal cabins have non-compliant and/or inaccessible chair clearances as marked in the floor plans (except for the rooms that were locked and not reviewed) and few of them have non-compliant and/or inaccessible entry widths towards the users' side of the table making these cabins non-compliant and hard for PwDs to use

3	Doors: All the non-compliant style door handles and locks should be replaced with accessible handles and locks that are easy to operate with fists and placed at accessible height as shared in Guideline 4 and have high contrast against the background door panel	H	M
4	Doors: All the non-compliant width doors should be replaced with accessible open width of 900 mm and vision panels corrected wherever required to start from 800 mm and go till 1500 mm	H	M
5	Doors: All doors as specified, should have a door clearance of 300 mm on the push side and 600 - 650 mm on the pull side barring men's and women's toilets as well as the emergency exit doors where it should be 450 mm on the push and pull side	H	H
6	Doors: Door tension needs to be reduced to 20 Newton by reducing the door closer tension for all doors	H	L

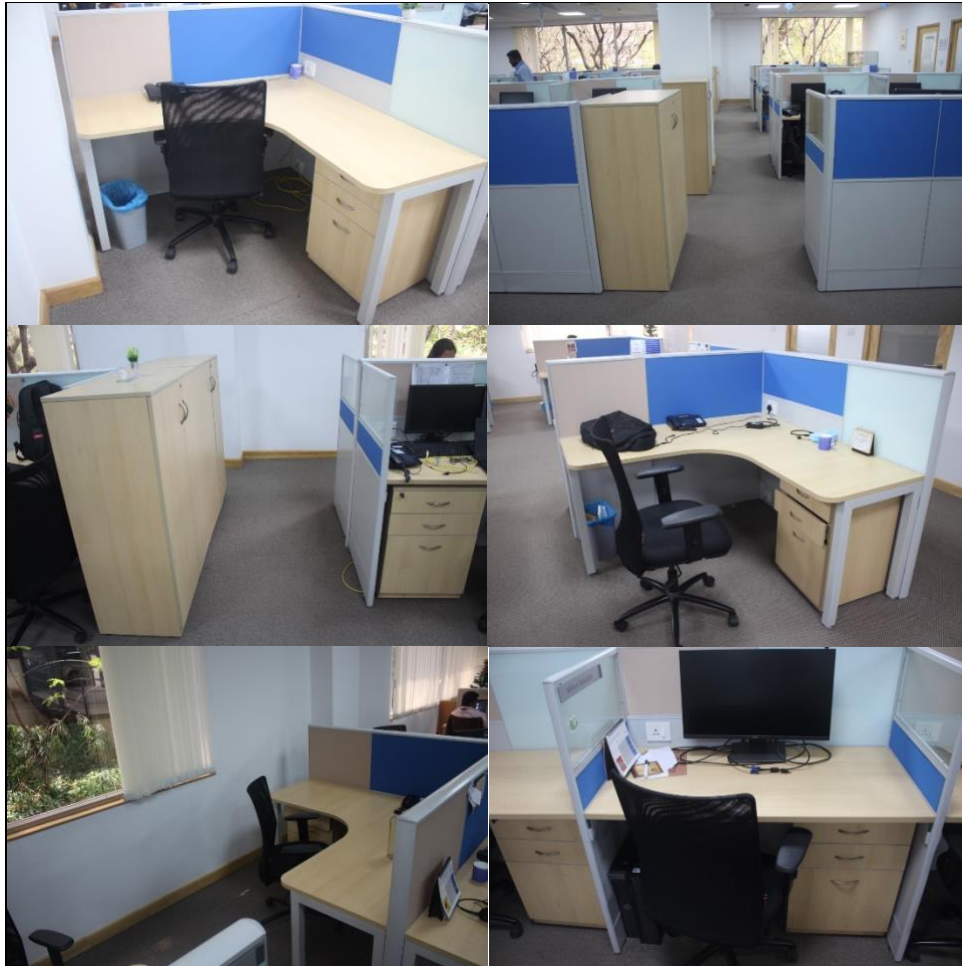
➤ A lot of points in the circulation paths and cubicle entries across the work floors have inaccessible widths as marked in the floor plans which will make the areas beyond these points completely inaccessible for PwDs

- A lot of points in the circulation paths and cubicle entries across the work floors have non-compliant widths and some of the pathways around the work seating in the circulation paths have practically hard to navigate widths as marked in the floor plans and will act as roadblocks for PwDs making these areas practically difficult for PwDs to navigate around

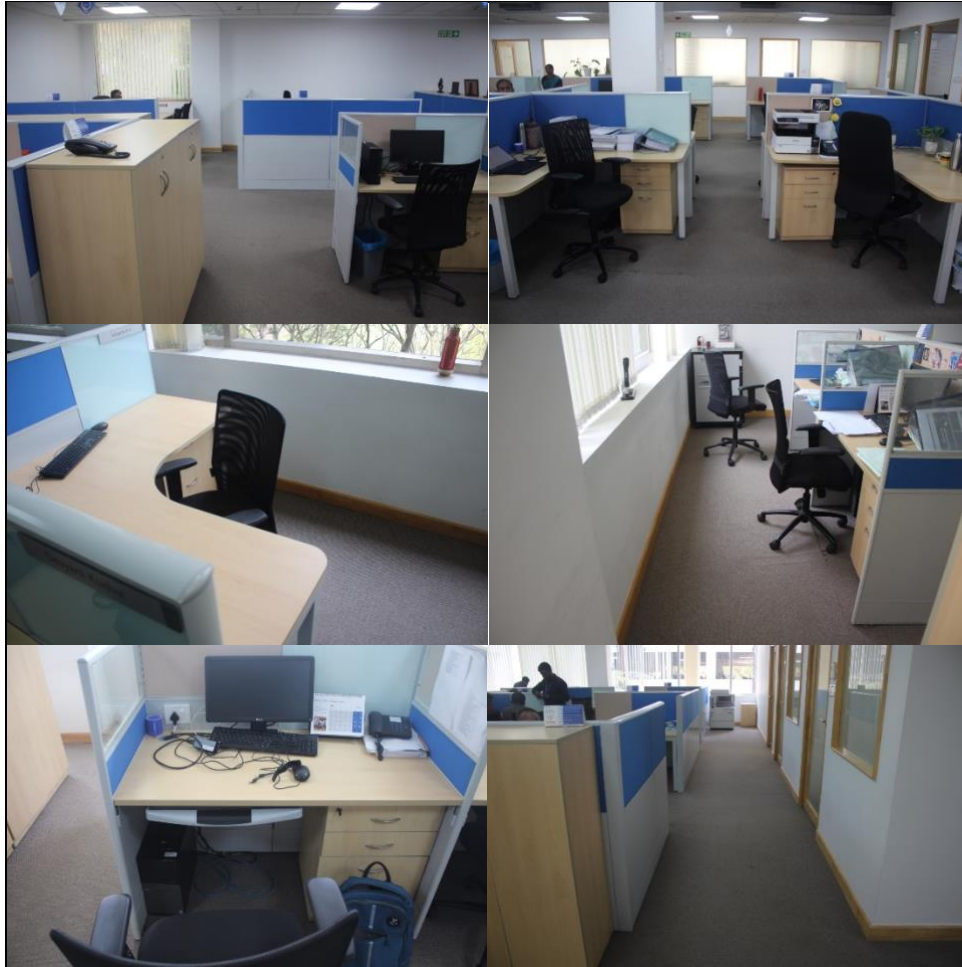
- The linear style workstations have keyboards that compromise knee clearances for wheelchair users making these workstations inaccessible to use
- The workstation storage pedestals as well as storage cabinets are inaccessible for people with certain types of hand impairment because of the locking mechanism and handle type

- The workstation storage pedestals as well as storage cabinets need braille labels as when people with visual impairment are hired in those areas

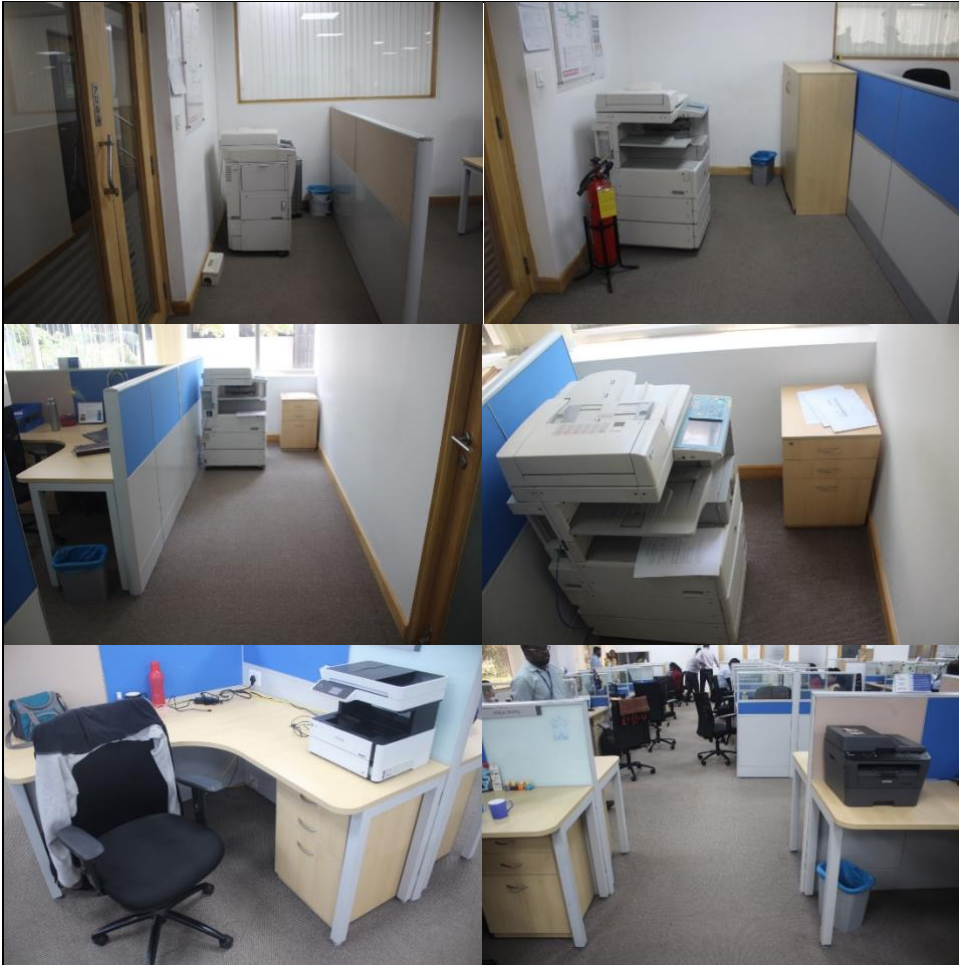
- A lot of the printers across the work floors do not have clear access space in front of them for wheelchair users to be able to access and use them
- The table top printers are placed at inaccessible heights for certain PwDs to be able to use it
- There is no identification or directional signage marking the placement of printer in the floor with provisions for braille and tactile making it non-compliant
- None of the printers have audio out provision making them inaccessible for people with visual impairment

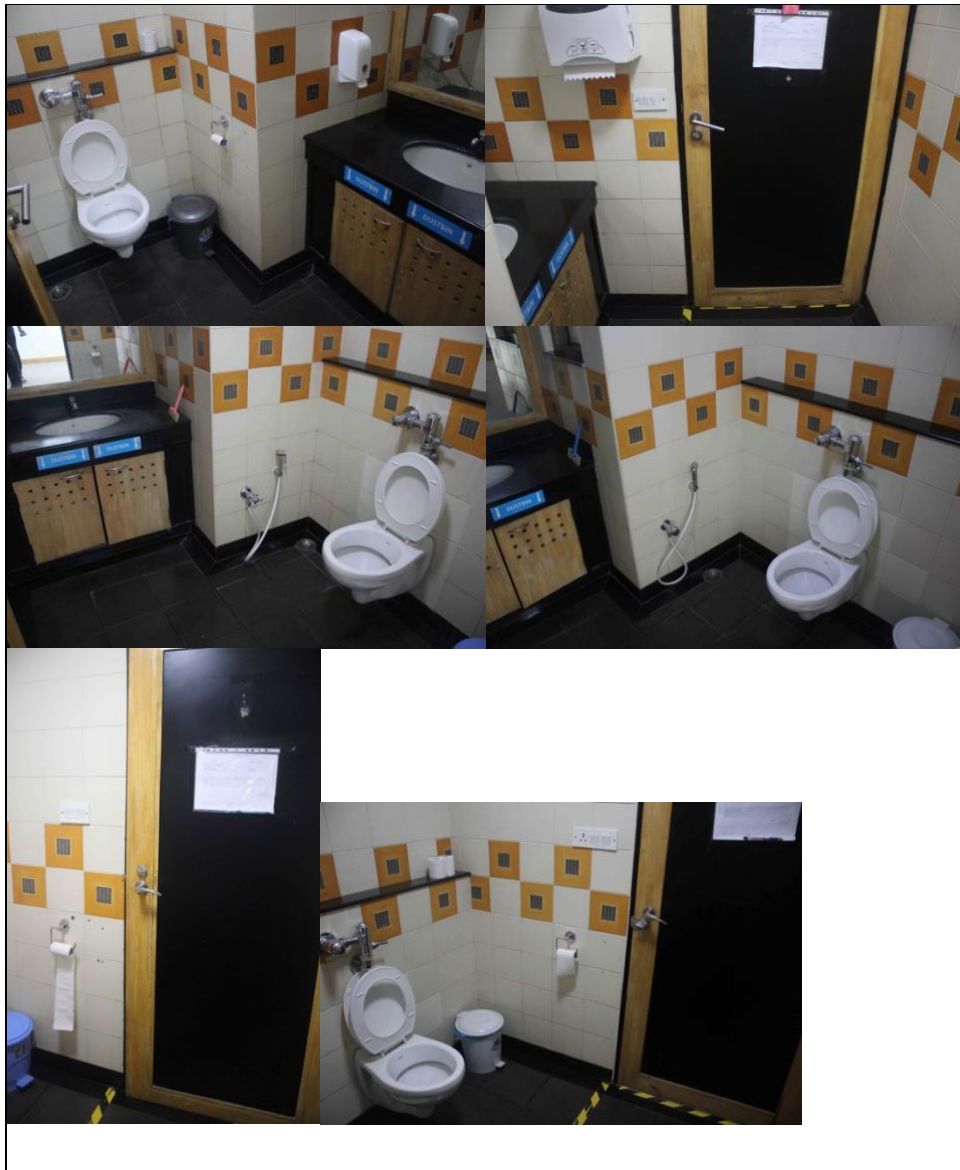
PWD RESTROOMS	
	➤ There is no PwD restroom in the third floor at all making this floor non-compliant and completely inaccessible for certain PwDs

- The ground floor PwD restroom access is via a corridor that has non-compliant path width
- All three PwD restrooms have signage placed at non-compliant heights with no provisions for braille and tactile and inappropriate text and symbols making these signage and the identification process non-compliant and inaccessible

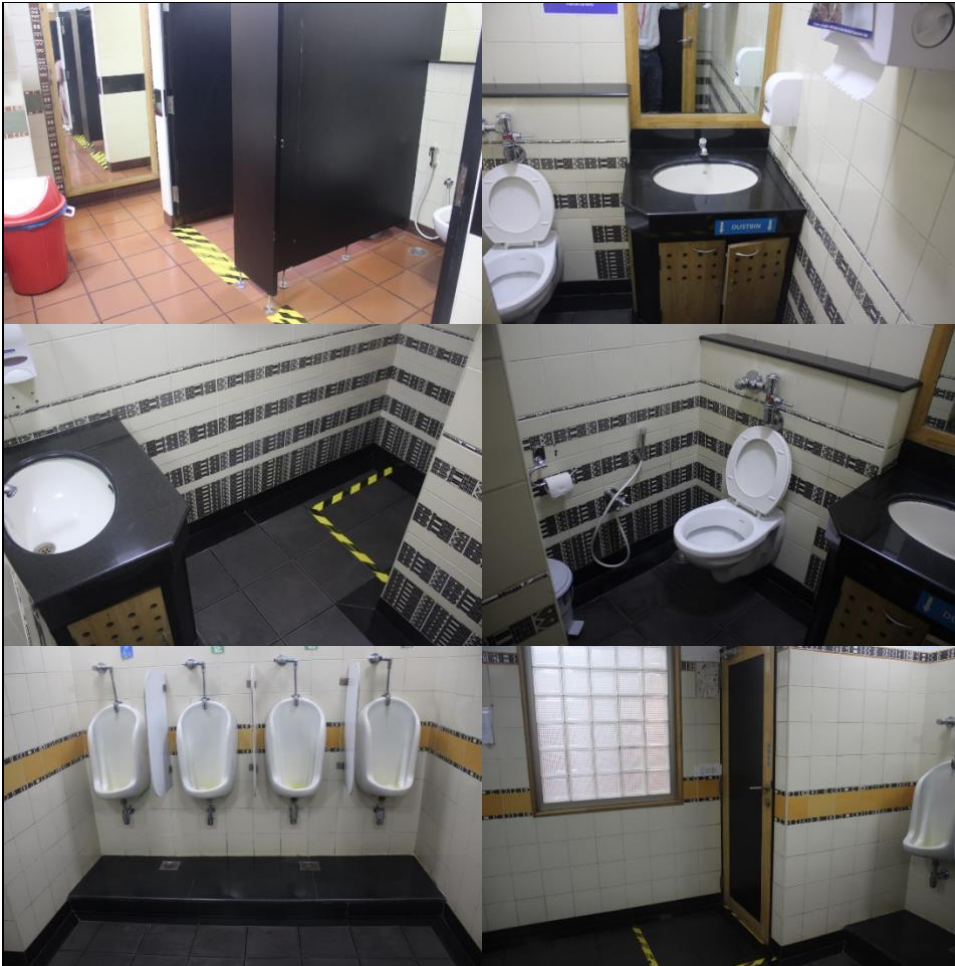
<ul style="list-style-type: none"> ➤ All the men's and women's restrooms' in the office building have entry doors with high door tension, non-compliant and/or inaccessible door widths, handles placed at non-compliant heights, and signage placed at non-compliant to inaccessible heights with no provisions for braille and tactile making these entries non-compliant and inaccessible for PwDs ➤ All the women's restrooms' in the office building have inaccessible pull side door clearances making them inaccessible for people with ambulatory disabilities ➤ All the men's and women's restroom entry doors in the office building have minor ledges at entry doors that can be unsafe for people using mobility aids ➤ Both the first and second floor conference room toilets have high door tension, inaccessible door widths, non-compliant handle heights, and
--	---

<p>signage with no provisions for braille and tactile making entry to these toilets non-compliant and inaccessible for certain PwDs</p>
<p>➤</p>	<p>The first floor conference room toilet does not have pull side door clearance and the tissue paper holder placed in the niche acts as a projection making it unsafe and the entry inaccessible for certain PwDs</p>
<p>➤</p>	<p>Both the first and second floor conference room toilets are congested and will be hard for certain PwDs to use these restrooms</p>
<p>➤</p>	<p>Both the canteen men's and women's restrooms have signage placed at inaccessible and non-compliant heights with no provisions for braille and tactile making these entries non-compliant</p>
<p>➤</p>	<p>All the men's restrooms have urinals at step levels that makes them harder to access and use for people with ambulatory disabilities and additionally reduces the clear space in front of the urinals for access making them non-compliant and inaccessible</p>

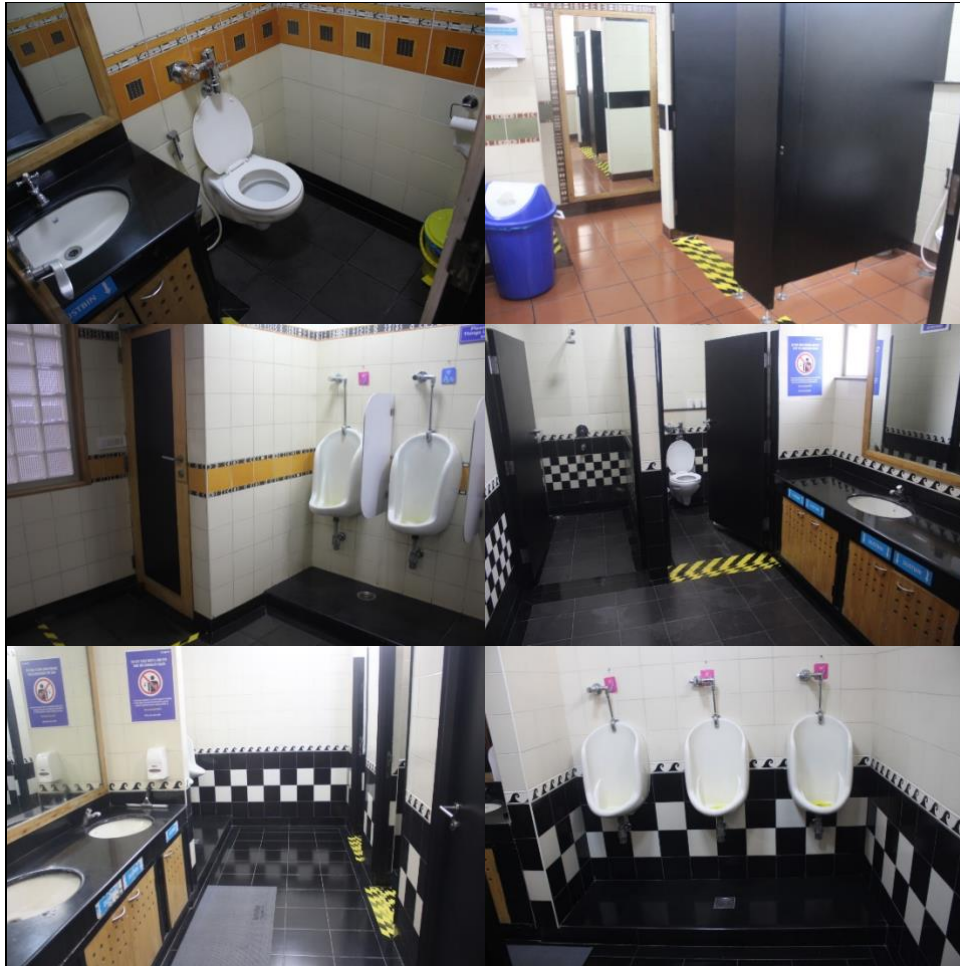
<p>➤</p>	<p>None of the men's restrooms have an accessible urinal at an appropriate height with supportive aids as required by compliance making it hard for people with ambulatory disability to use restroom facilities</p>
<p>➤</p>	<p>Neither of the men's or women's restrooms have a provision for one ambulatory disabled-friendly cubicle per restroom and are inaccessible additionally because of the inward opening doors, inaccessible entry door widths, non-compliant handle types or heights and lack of supportive aids for the ambulatory disabled making them non-compliant and inaccessible for the ambulatory disabled</p>
<p>➤</p>	<p>All the restrooms have slippery floors that can be unsafe and are non-compliant</p>
<p>➤</p>	<p>Some of the restrooms have hand dryers and/or tissue paper holders placed at points where they act as projections and can be unsafe for PwDs and are non-compliant</p>
<p>➤</p>	<p>Some of the restrooms have loose mats near the entry doors or hand sinks which can be unsafe for certain PwDs and are non-compliant</p>

- None of the restrooms have blinkers connected to the emergency system in case of an emergency as required by compliance

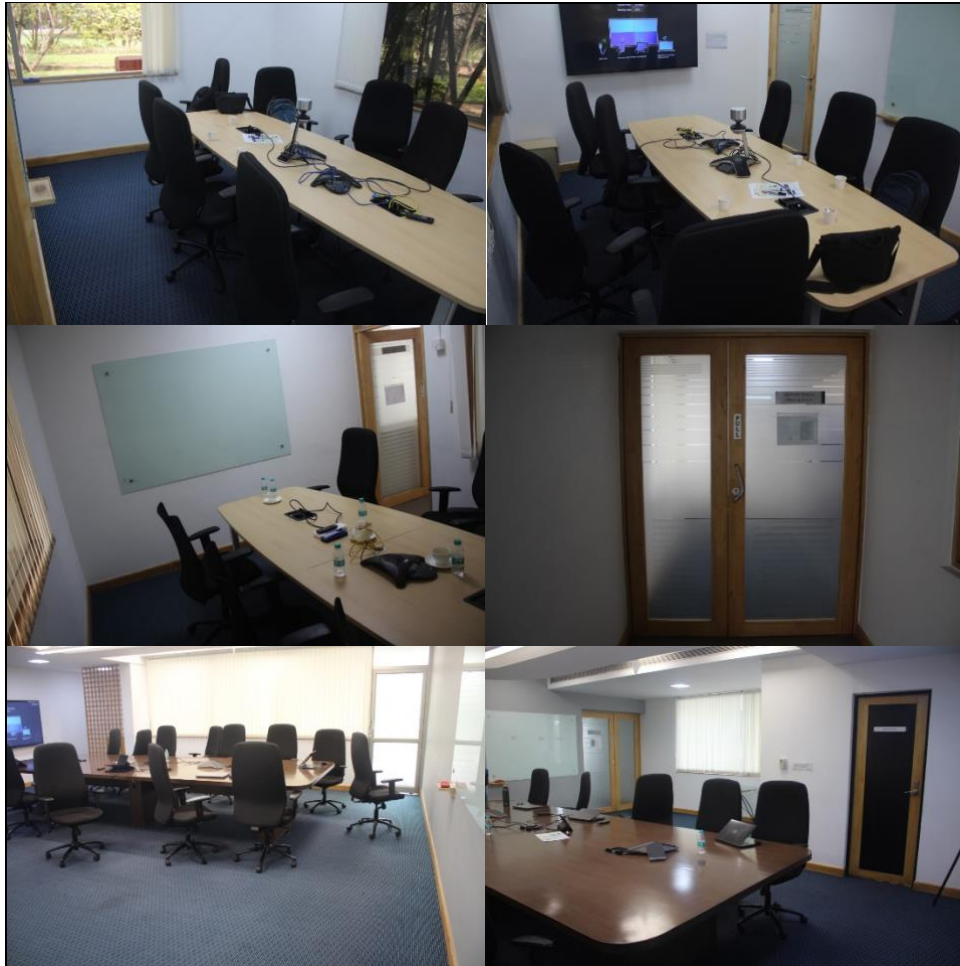
- All the conference rooms' entry doors have high door tension, non-compliant door widths (except for one conference room in second

<p>floor), and handles placed at non-compliant heights except for the conference rooms with long vertical handles that are placed at inaccessible heights making these entries non-compliant and inaccessible for PwDs</p>
➤	<p>All the conference rooms with signage have them placed at non-compliant heights with no provisions for braille and tactile and the rest don't have signage at all making these entries non-compliant and inaccessible</p>
➤	<p>The conference room on first floor with toilet has non-compliant and inaccessible pull side door clearance making this entry non-compliant and inaccessible to access for certain PwDs</p>
➤	<p>Most of the conference rooms have non-compliant and/or inaccessible chair clearances as marked in the floor plans making these rooms either completely and/or that part of the conference room inaccessible and non-compliant for PwDs</p>
➤	<p>None of the conference rooms have loop induction units as per compliance to support people with hearing impairment</p>

➤	<p>All the conference rooms have whiteboards placed at heights that reduces the optimal usage area for certain PwDs</p>
➤	<p>Some of the conference rooms have marker holders that may act as projection and be unsafe for PwDs</p>
➤	<p>The conference room in the second floor with the toilet inside has cable cubbies placed at inaccessible depths making them inaccessible for certain PwDs to access and use</p>
➤	<p>The light switches in all conference rooms are placed at non-compliant heights with no colour contrast against the background walls making them non-compliant</p>
