SYNGENE INTERNATIONAL LTD, VELANKANI TECH PARK, ACCESSIBILITY AUDIT REPORT

PREPARED BY SVADHIN SOLUTIONS

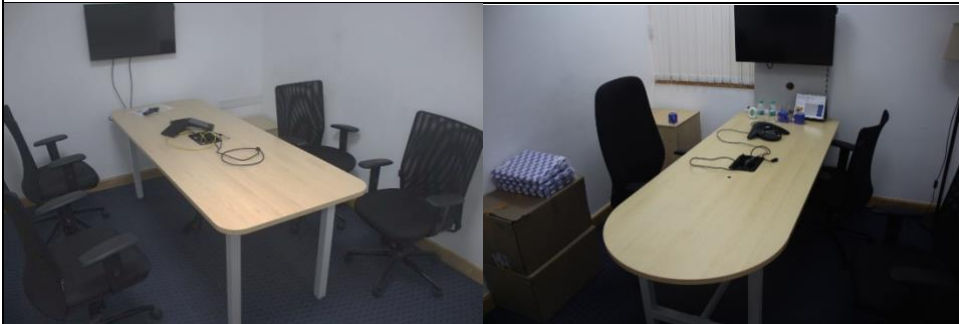
- All the meeting room entry doors have high door tension (except for three meeting rooms in the second floor), non-compliant door widths (except for one of the meeting rooms on first floor and three of the meeting rooms on second floor) and handles placed at non-compliant heights except for one of the meeting rooms with vertical long handles which is placed at inaccessible height making these entries non-compliant and inaccessible for PwDs
- All the meeting room entry doors have signage placed at non-compliant to inaccessible heights except for two that are at accessible heights and two that have no signage in place at all and none of the signage in place has provisions for braille and tactile making these entries non-compliant and inaccessible for certain PwDs
- Few of the meeting rooms have inaccessible pull and push side door clearances making these entries inaccessible for PwDs

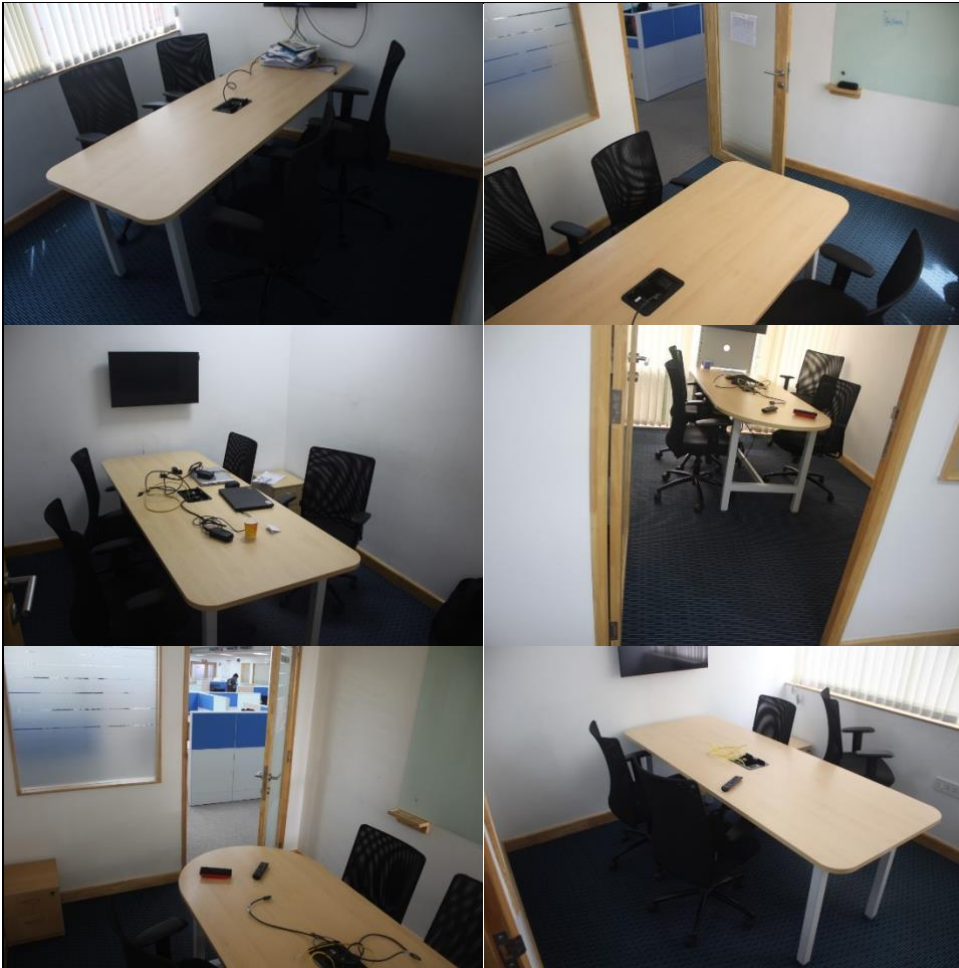
- Almost all the visited meeting rooms have either non-compliant and/or inaccessible chair clearances as marked in the floor plan making these points congested and hard to use for PwDs

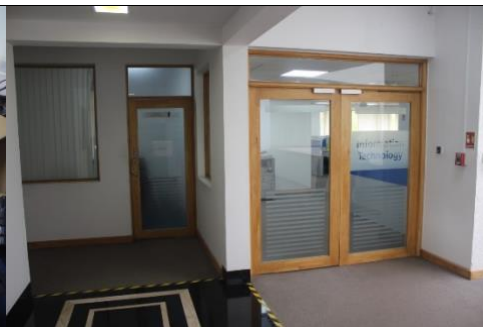
- The IT Helpdesk entry door has high door tension, no pull side door clearance, non-compliant door width, non-compliant handle height and signage placed at non-compliant height with no provisions for braille and tactile making this entry non-compliant and inaccessible for PwDs
- The IT helpdesk room is highly congested with lot of materials stored inside making this room inaccessible and unsafe for most PwDs
- The IT helpdesk room table has inaccessible chair clearances which would make it hard for a lot of PwDs to work here

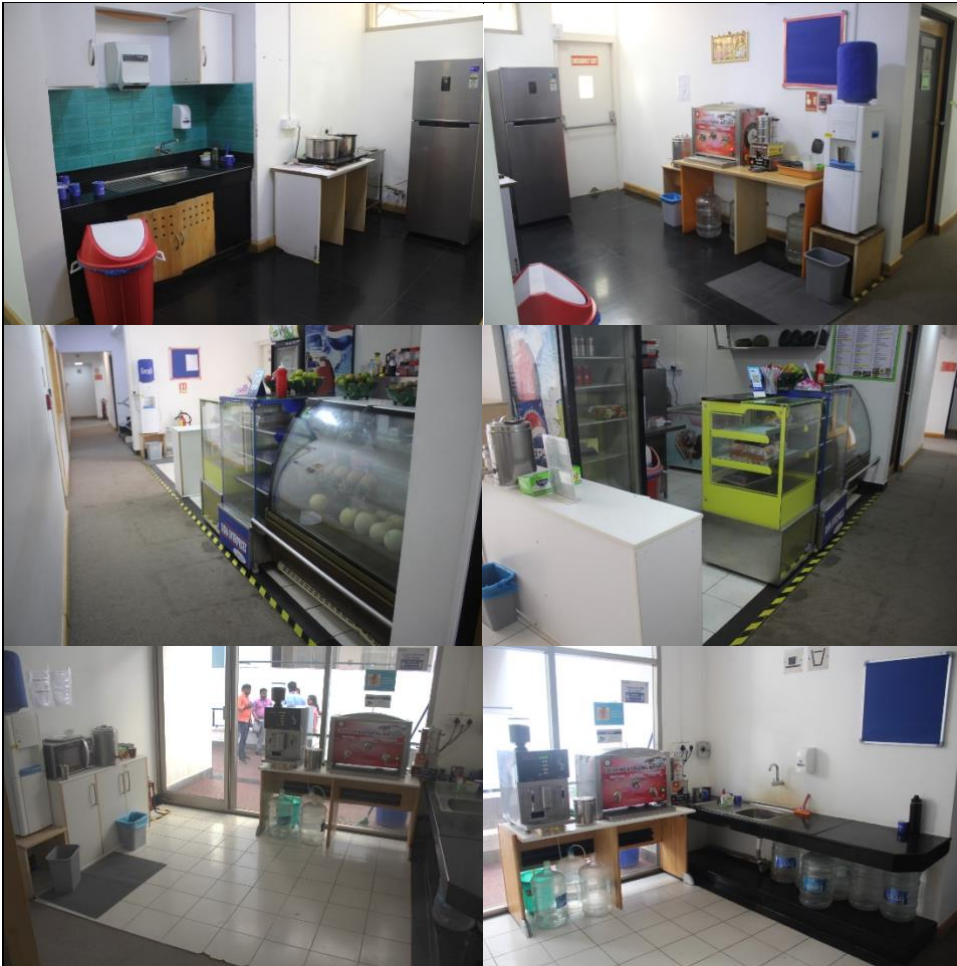
- The third floor pantry entry door has high door tension, non-compliant door width, inaccessible pull side door clearance, handles placed at non-compliant and inaccessible heights, inaccessible vision panel, ledge at the entry door and signage placed at non-compliant heights with no provisions for braille and tactile making this entry non-compliant and inaccessible

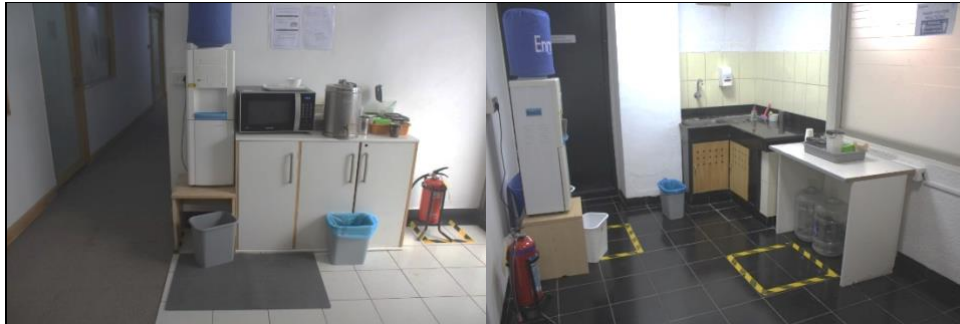
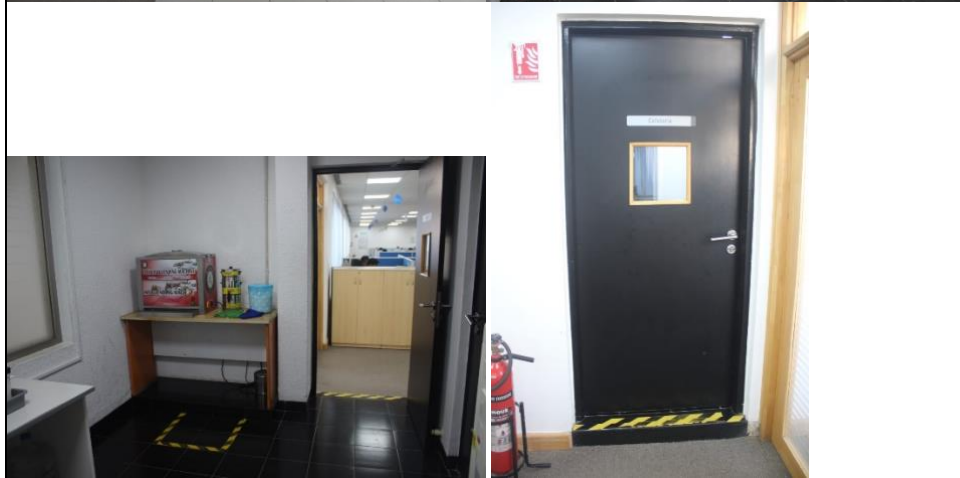
- All the water dispensers taps are at non-complaint heights
- Loose mats placed in the ground and second floor pantries are unsafe for PwDs and are non-compliant

- The ground, first and second floor pantries do not have any identification signage in place with provisions for braille and tactile making navigation challenging for PwDs and non-compliant

- All the pantries have slippery floors that can be unsafe for PwDs and are non-compliant

27	Flooring: All areas where lack of anti-slip flooring is mentioned should be made anti-slip by changing the tiles or having other form of anti-slip treatment to the tiles or flooring	H	M
28	Counters: Inaccessible counters like the reception counters, security sign-in, food counter and the tuck shop cash counter should be replaced with wheelchair accessible counters as shared in Guideline 5 and have knee clearance of at least 480 mm below the counter	H	H
29	Coffee Machines & Microwaves: A braille reading option should be added to all machines for people with visual impairment and the coffee machine panel heights should be as shared in Guideline 5	H	L
30	Canteen: Braille menus should be introduced for the tuck shop counter	H	M
31	Drinking Water Setups: Use Automated drinking water setups or ones with lever taps that are accessible at 800 – 1000 mm with minimal depth to reach the drinking water taps	H	L

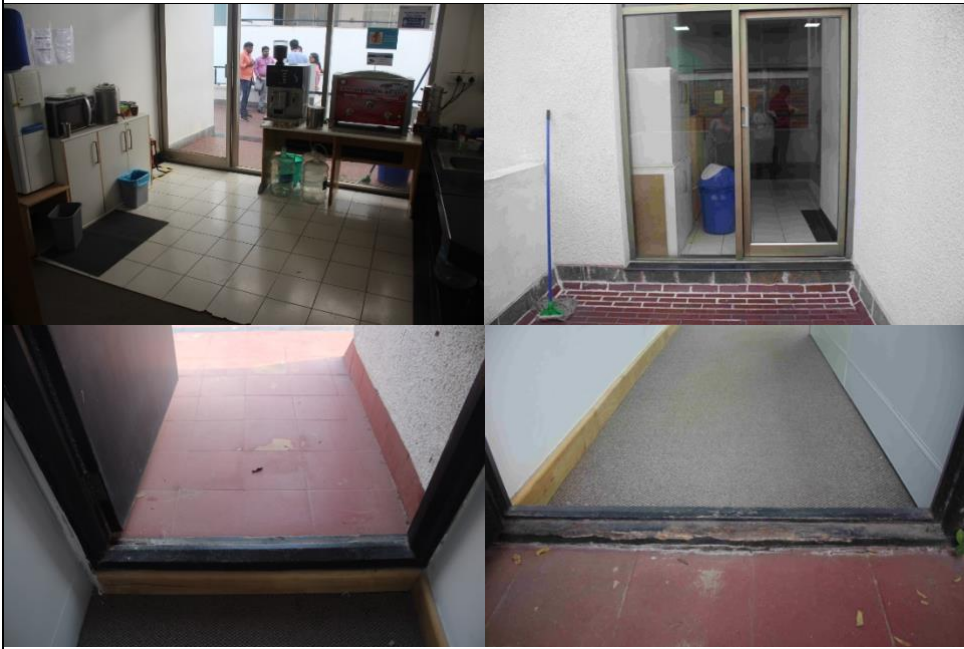
- All the balcony doors are at step levels making the balconies hard to access for wheelchair users
- The first floor balcony door has high door tension, inaccessible door width, handles placed at inaccessible heights with no contrast against the door frame, and door that does not contrast strongly against the background glass wall panel making this entry non-compliant and inaccessible for PwDs

- The second floor balcony door has non-compliant door width, handles placed at inaccessible heights with no contrast against the door frame, and door that does not contrast strongly against the background glass wall panel making this entry non-compliant and inaccessible for PwDs

- The second floor balcony has a step level in the balcony area that is left unmarked making it unsafe for PwDs and harder to use for certain PwDs
- The third floor balcony with a single door for access has an entry door with high door tension, non-compliant door width, inaccessible handle height and no push side door clearance making this entry non-compliant and inaccessible for PwDs

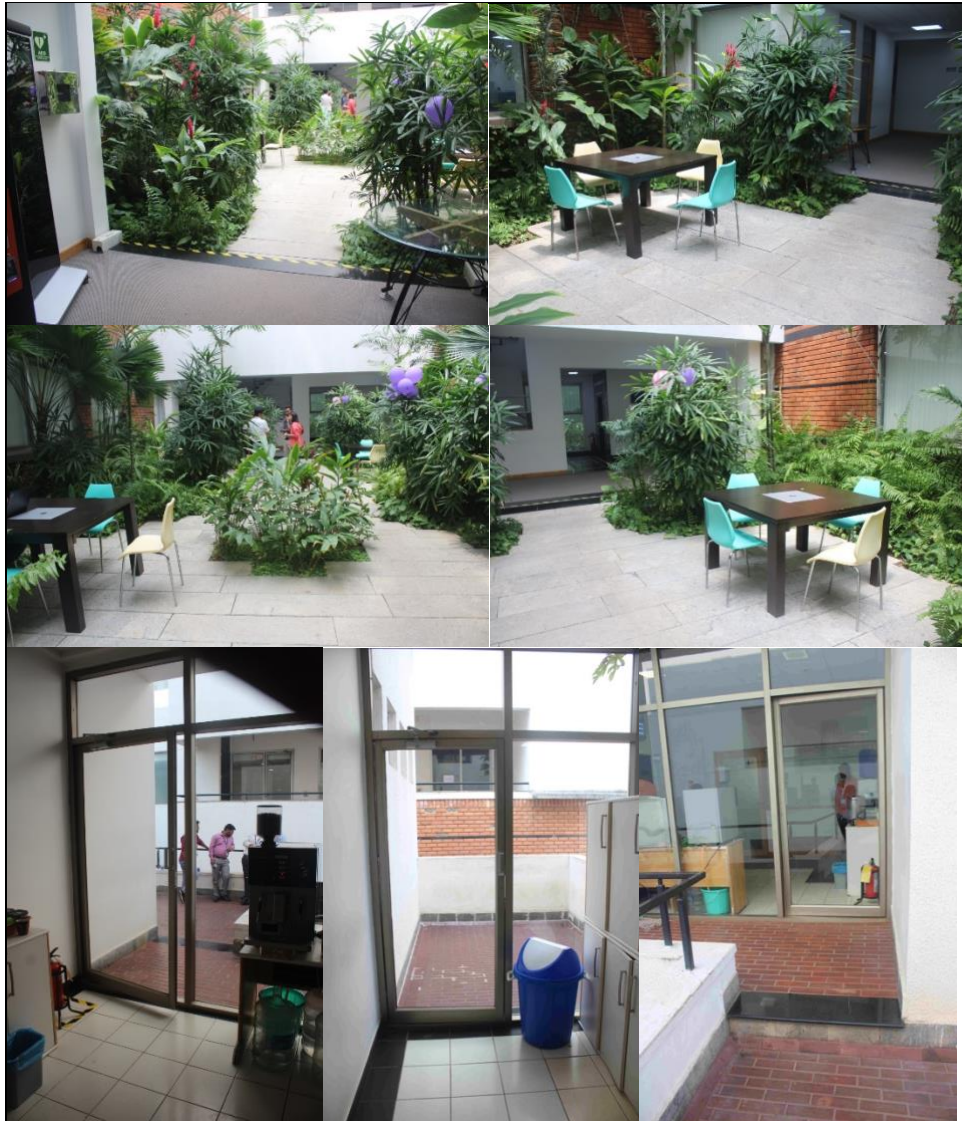
- The third floor balcony on the other side has entry doors that have non-compliant door widths, inaccessible handle heights and while one of the doors does not have push side door clearance, the other one doesn't have push and pull side door clearances making both these entries non-compliant and inaccessible for PwDs
- None of the balcony doors have accessibly placed signage with provisions for braille and tactile making navigation here challenging for PwDs and non-compliant
- The ground floor courtyard access is via steps which makes navigating through it inaccessible for wheelchair users
- The ground floor courtyard pathway has inaccessible points as marked in the floor plan in the centre of the navigation route which makes it hard to use for most PwDs and non-compliant

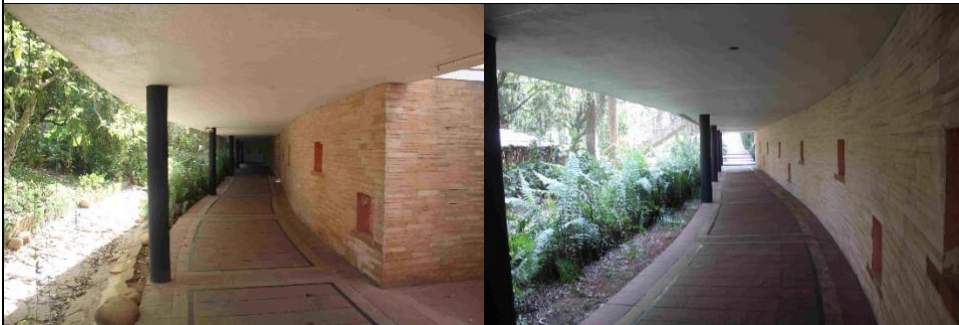
- The route to the canteen from the office building has uneven flooring, level differences/step level at certain places including the footpath to the road access which is missing kerb ramps making this route inaccessible for certain PwDs and unsafe for others and non-compliant
- The canteen can only be accessed via multiple flights of steps without an alternative accessible route for wheelchair users making this building and facility inaccessible and non-compliant
- The flight of steps leading to the canteen floor do not have colour contrast markings on the edge of the step treads, have handrails at non-compliant heights without any handrail extensions and the last flight of steps have non-compliant width making this route non-compliant
- Loose mats placed near the staircase, entry doors and inside the canteen can be unsafe for PwDs and are non-compliant

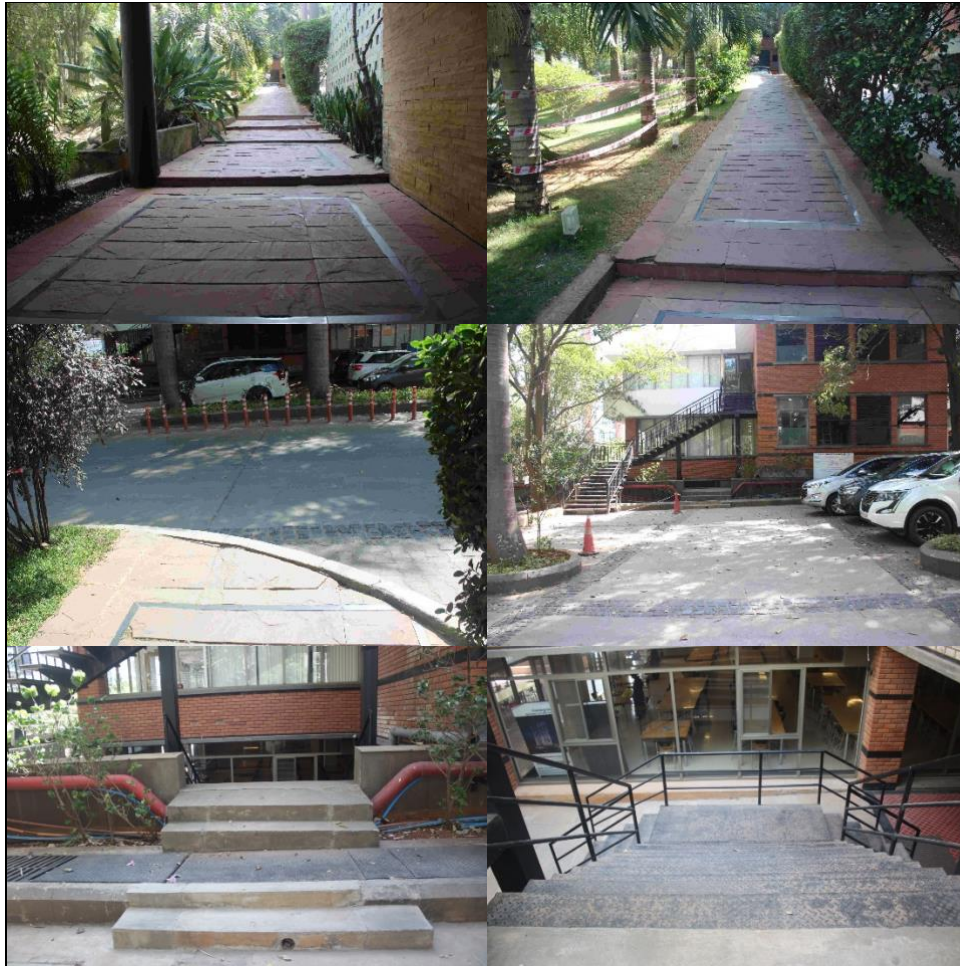
- The canteen entry door has no pull side door clearance, handles placed at non-compliant heights with no contrast against the background door panel, doors that do not stand out against rest of the glass panels and no signage with provisions for braille and tactile making this entry non-compliant and inaccessible for PwDs

- The canteen floor can become slippery in the presence of water making this flooring unsafe for PwDs and non-compliant
- The microwave is placed at a non-compliant height and depth and the microwave control panel do not have provisions for braille and tactile to support people with visual impairment making it inaccessible and non-compliant for PwDs

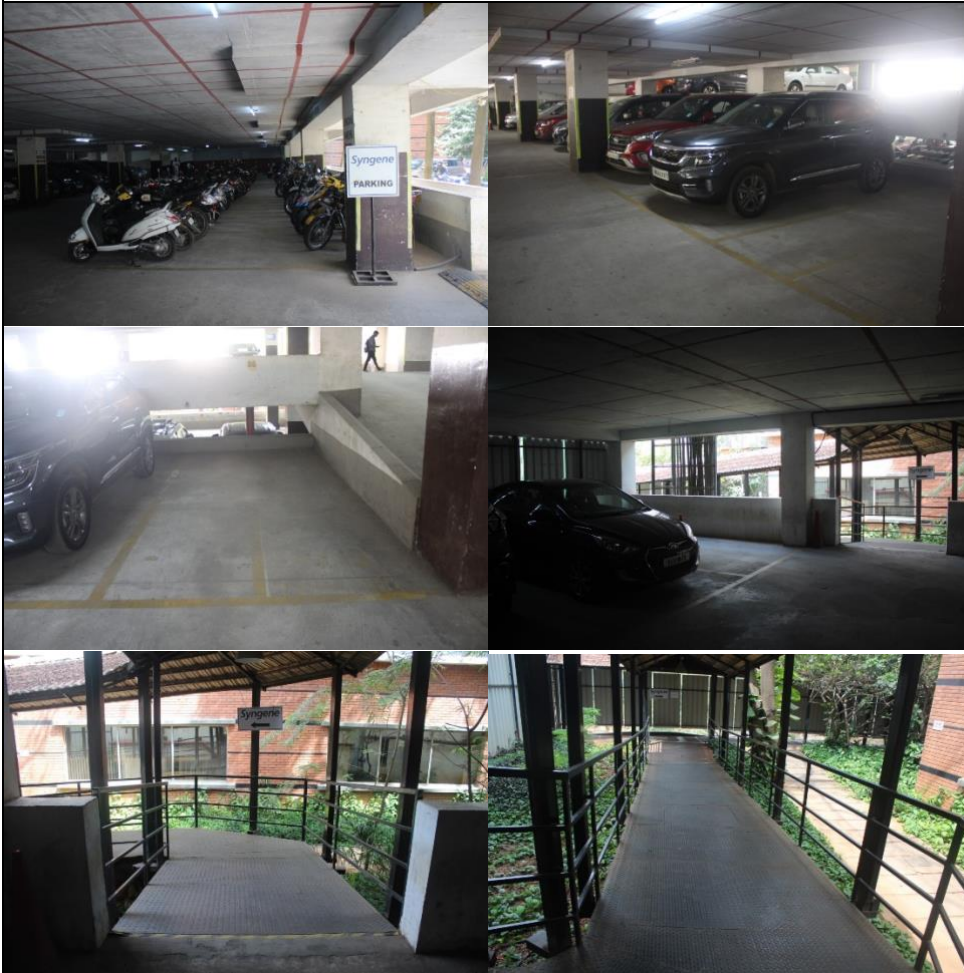
- There are no accessible two wheeler parking spots marked and allocated for both PwD visitors' and employees which makes it non-compliant and inaccessible

- There are no directional and identification signage guiding people out of the parking to the building entrance
- The ramp connecting the parking to the building entrance has inaccessible gradient, missing mid-landings, no edge protection, no continuously running dual level handrails at appropriate heights with handrail extensions and no signage identifying this facility for use making this ramp inaccessible and non-compliant for PwDs

- The pathway from the parking to the building entrance has uneven surface which can be unsafe for PwDs and is non-compliant

13	Steps and Ramps: All steps and ramps should have handrails on both sides next to them extending 300 mm out on both sides with a diameter of 38-45 mm and the ramp should have dual level handrails at 950 mm top height and 750 mm lower level handrail top height while for staircases handrail height should not exceed 950 mm	H	M
14	Ledges and Level Differences: All ledges, level differences and uneven broken paths that act as ledges in the circulation path and to access various facilities should be smoothed out so a wheelchair can easily pass through the space	H	-
15	Staircases: Handrails may have braille embedded to indicate floor level	H	L
16	Staircases: Handrails should have continuous handrails on both sides at 900-950 mm height with handrail extensions that curve towards the end for 300 mm after the last step indicating the floor landing	H	M

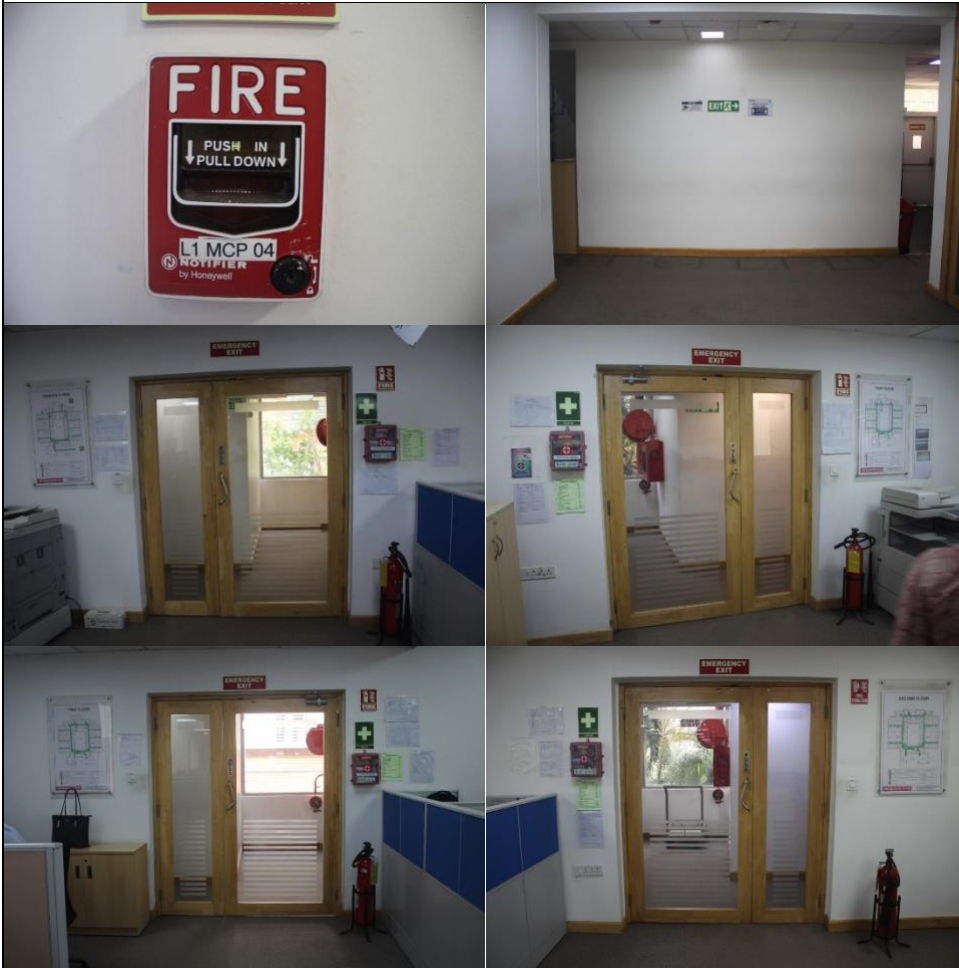
- All the emergency evacuation maps are placed at non-compliant and inaccessible heights, have low colour contrast making them hard to read, have highly reflective surfaces and do not have provisions for braille and tactile making them non-compliant and inaccessible for PwDs

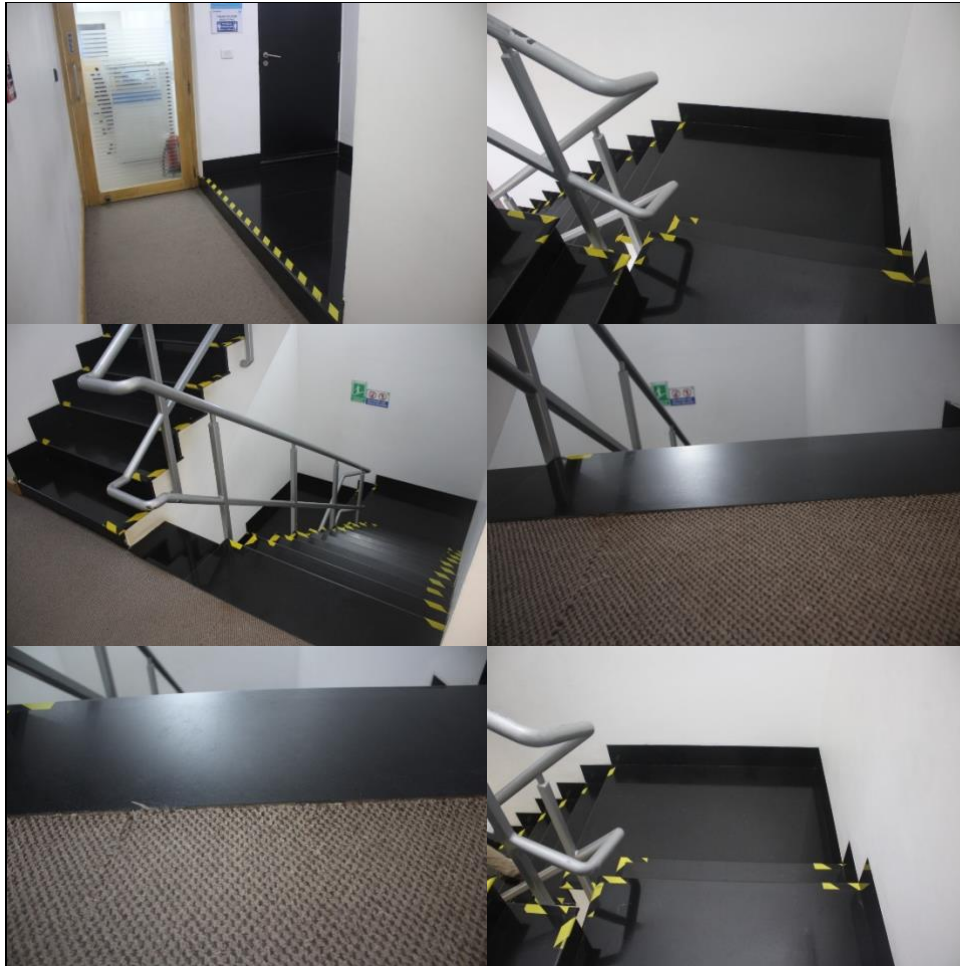
- The central running handrails of both the staircases (front and back) do not have handrail extensions at the top and bottom landings and the staircases are missing continuously running wall side handrails with extensions into the landings making both these staircases non-compliant and hard to use for certain PwDs

- The front staircase handrails on the left side below the beam for the flight that is coming into the landing areas have inaccessible clearance from handrail to the beam making this part of the handrails possibly unsafe for certain PwDs and the head clearance non-compliant

- All the steps in both the staircases have non-compliant colour markings and there are no antiskid provisions for all the step treads making both the staircases non-compliant and unsafe for PwDs
- Access to the front staircase from the third floor office entry has steps to access the staircase which don't have handrails and are missing anti-skid provisions for the step treads making them non-compliant
- The back staircase entry from the floor landings have small level differences because of the improperly flushed carpeted floors at certain points which may be unsafe for certain PwDs
